## BACKGROUND & PROBLEM

### CARUSOL® for Landfill Leachate Hydrogen Sulfide Odor Control

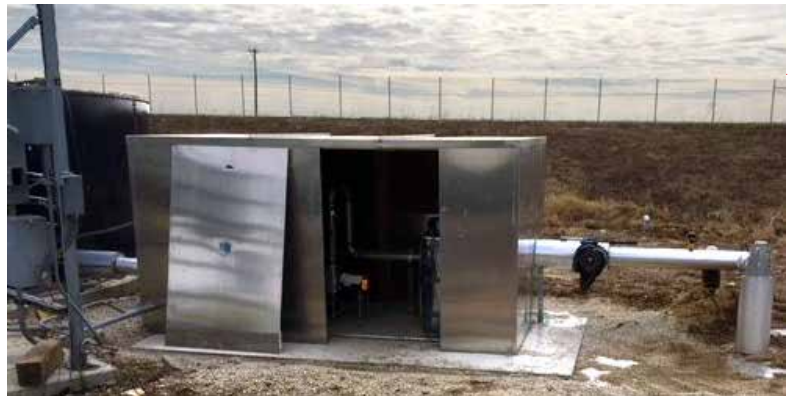
**Figure 1: Leachate Lift Station**

The leachate flows from two separate landfill cells. One is open and the other is partially capped. The open cell generates an average of 20,000 gallons per day (gpd) with wide day-to-day variation. The partially capped cell contributes an average flow of about 5,000 gpd. In order to eliminate the odor and corrosion issues, both sources of leachate would need to be treated prior to entering the wet well at the lift station.

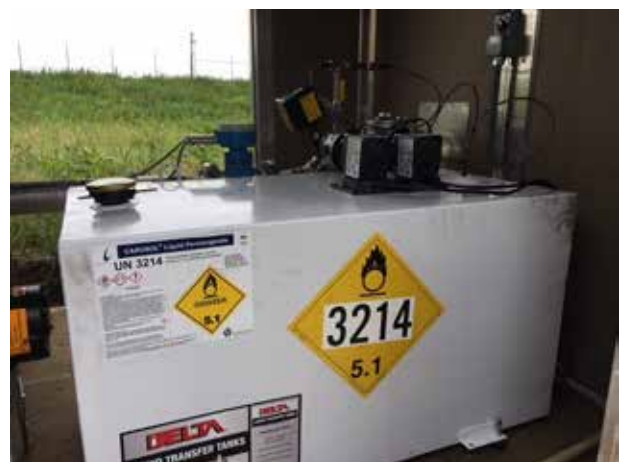
**Figure 2: CARUSOL Tank and Metering Pumps**

Metering pumps and storage tanks were set-up at two locations to treat the sources of leachate before entering the lift station.

The larger 20,000 gpd leachate flow was treated using two metering pumps. One pump was set at a fixed rate and the second on a timer to allow for CARUSOL dosage adjustment based on the time of day and the varying flow rates.

The smaller 5,000 gpd leachate flow was treated with one metering pump at a constant rate. CARUSOL usage averaged 6-8 gpd between the two application points.

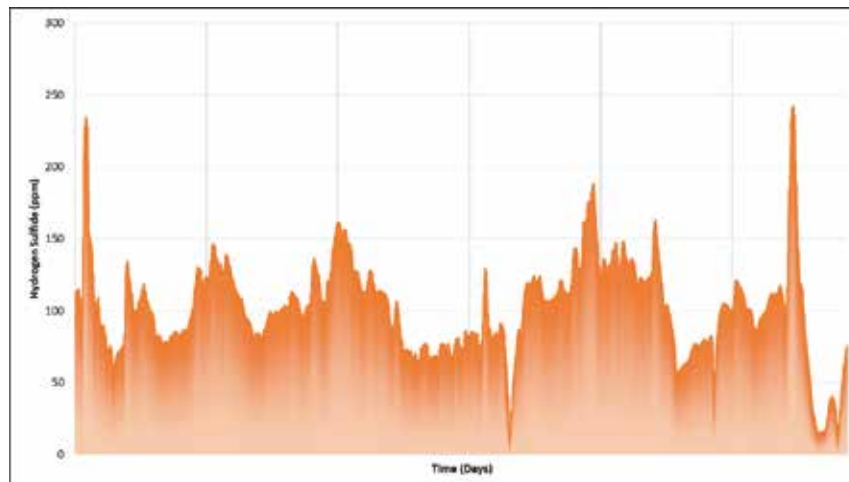
Figure 3: Hydrogen Sulfide Levels Upstream of CARUSOL® Treatment

Two Odalog® hydrogen sulfide analyzers were run simultaneously to generate our results. Upstream from CARUSOL® odor control treatment, the hydrogen sulfide levels averaged 99 ppm with peaks as high as 242 ppm (Figure 3). Down stream from treatment with CARUSOL, the hydrogen sulfide levels at the lift station averaged 0.40 ppm with peaks of only 6 ppm (Figure 4).

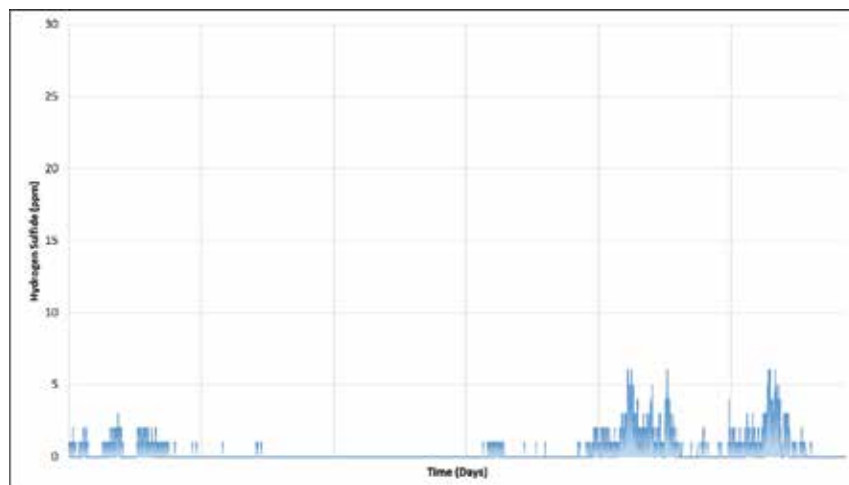
Figure 4: Hydrogen Sulfide Levels Downstream of CARUSOL® Treatment
